# UNDERWATER FACILITIES INSPECTIONS & ASSESSMENTS

**UNDERWATER FACILITIES  
INSPECTIONS  
AND  
ASSESSMENTS  
AT**

**PHILADELPHIA NAVAL SHIPYARD**

**FPO-1-83-(48)      OCTOBER 1983**

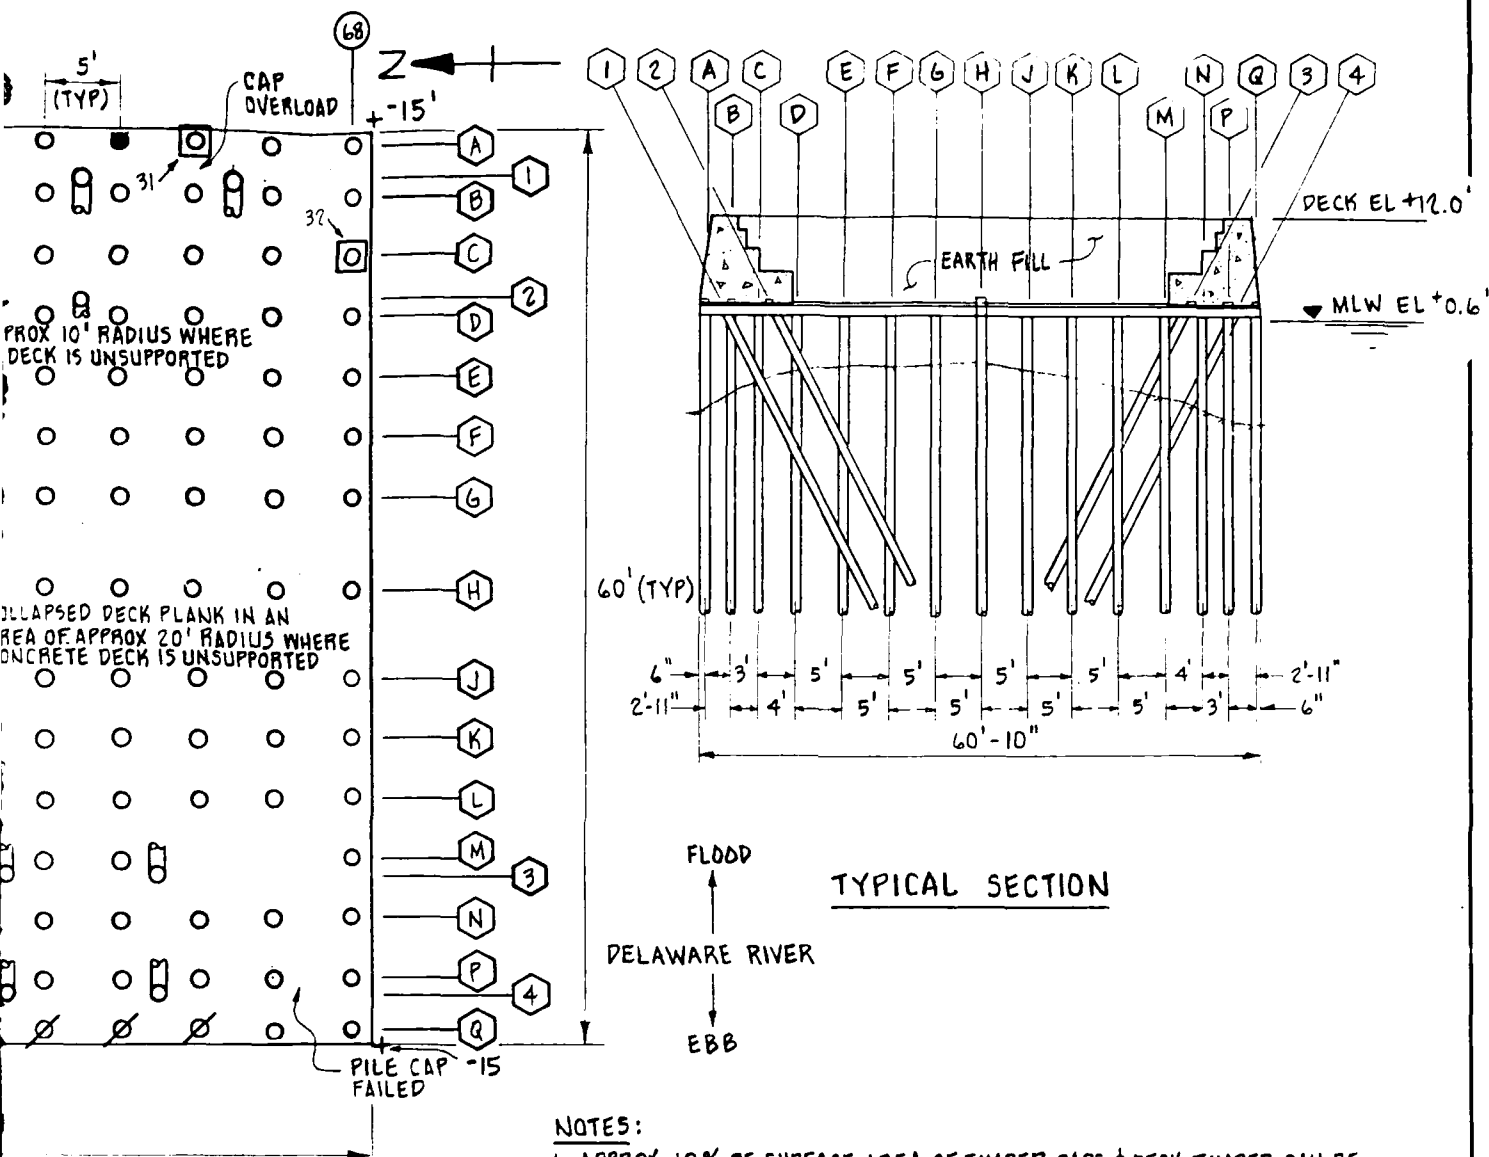
CHESAPEAKE DIVISION  
NAVAL FACILITIES ENGINEERING COMMAND  
WASHINGTON, D.C.  
PHILADELPHIA NAVAL SHIPYARD PHILADELPHIA, PA  
PIER 7  
FIG NO. 27

1. APPROX 10% OF SURFACE AREA OF TIMBER CAPS & DECK TIMBER CAN BE PROBED WITH A KNIFE TO A DEPTH OF 3"-4".
2. CORE SAMPLES INDICATE 1" OF SOFTNESS IS A TYPICAL CONDITION.
3. LEVEL 1 INSPECTION ON ALL PILES- HIGHER LEVELS OF INSPECTION WHERE NOTED.

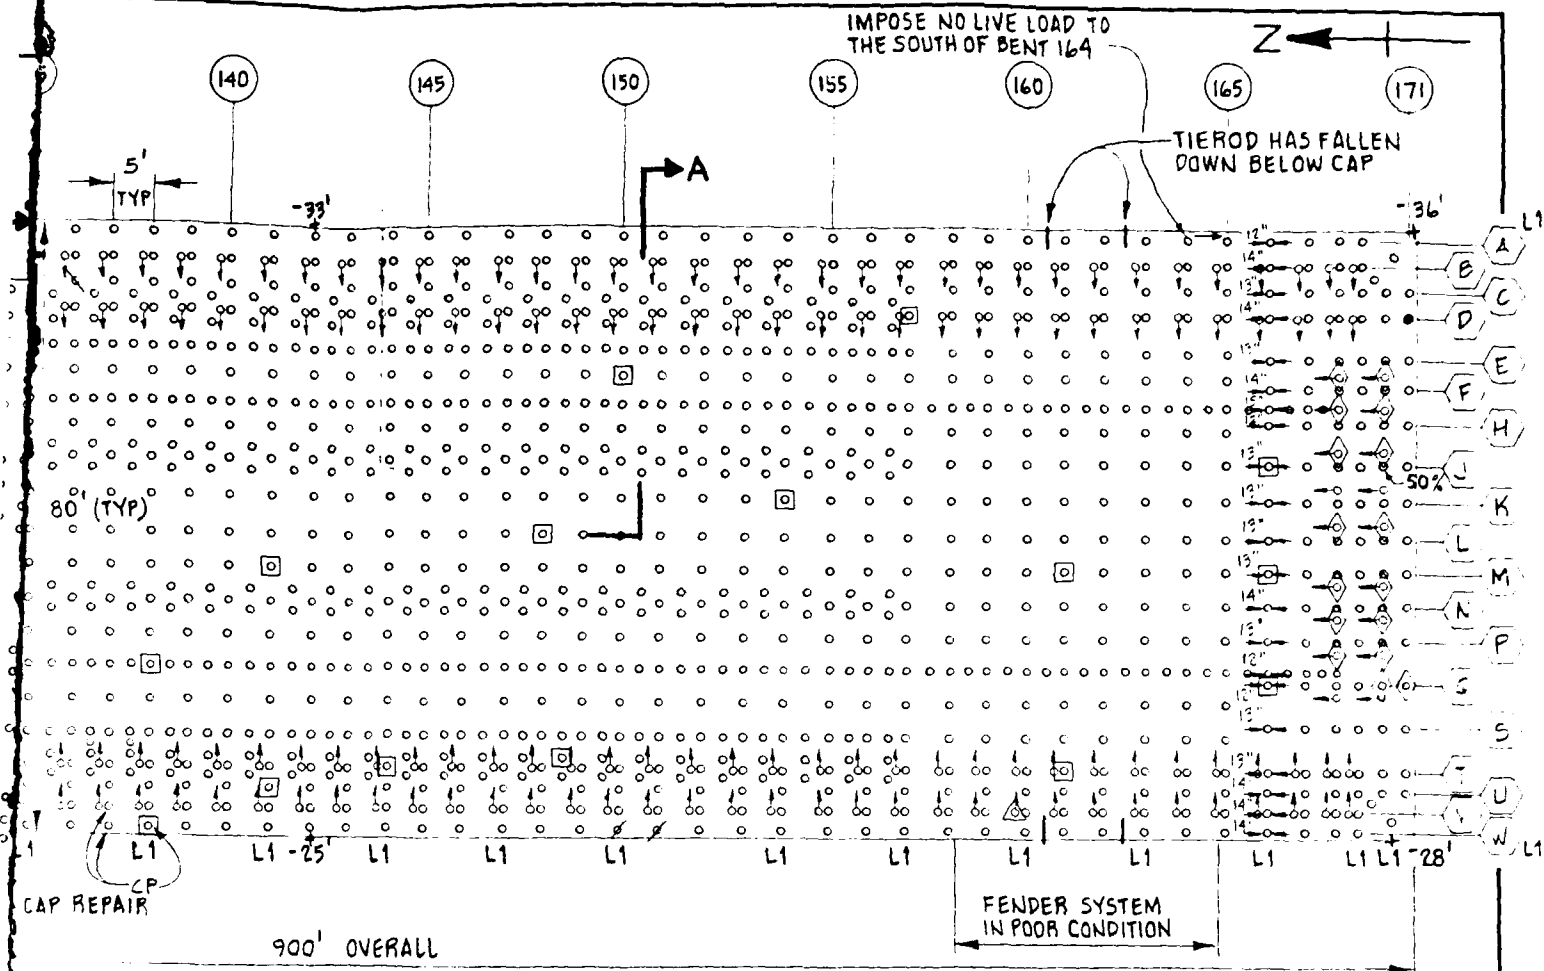
- 1) ALL BATTER PILES AT OUTSHORE END OF PIER ARE NON-BEARING.
- 2) ALL PILES INSPECTED MODIFIED LEVEL 1 UNLESS OTHERWISE NOTED.
- 3) TIE RODS OCCUR AT EVERY OTHER BAY.
